**DEFENDANT’S RESPONSE IN OPPOSITION
TO EMERGENCY MOTION FOR TEMPORARY RESTRAINING ORDER,
PRELIMINARY INJUNCTION, AND PERMANENT INJUNCTION**

AFFIDAVIT OF DYRON HAMLIN, MS, PE, CIH

Ethylene Oxide Air Monitoring Report

Village of Willowbrook

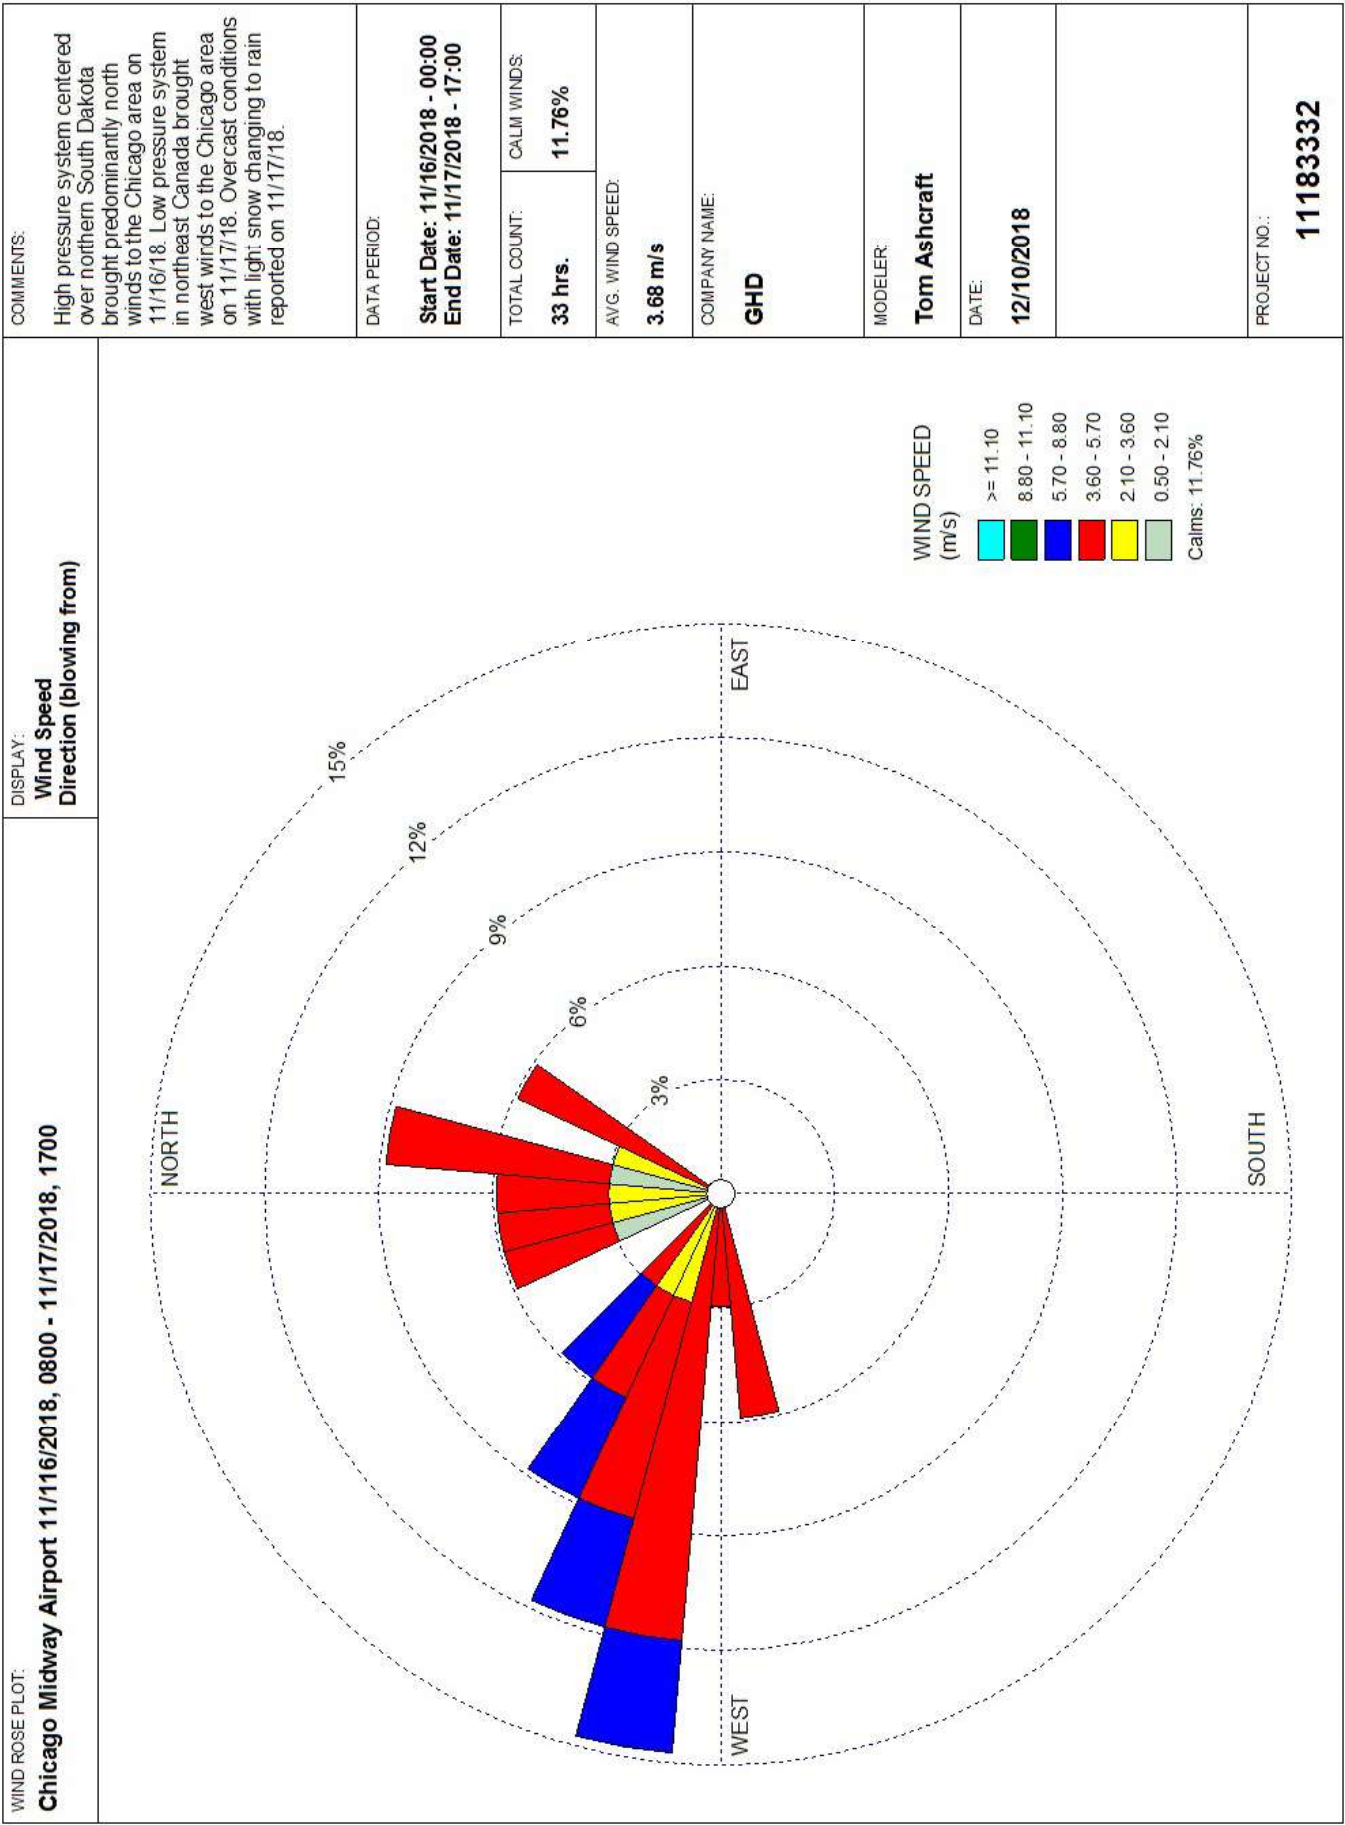
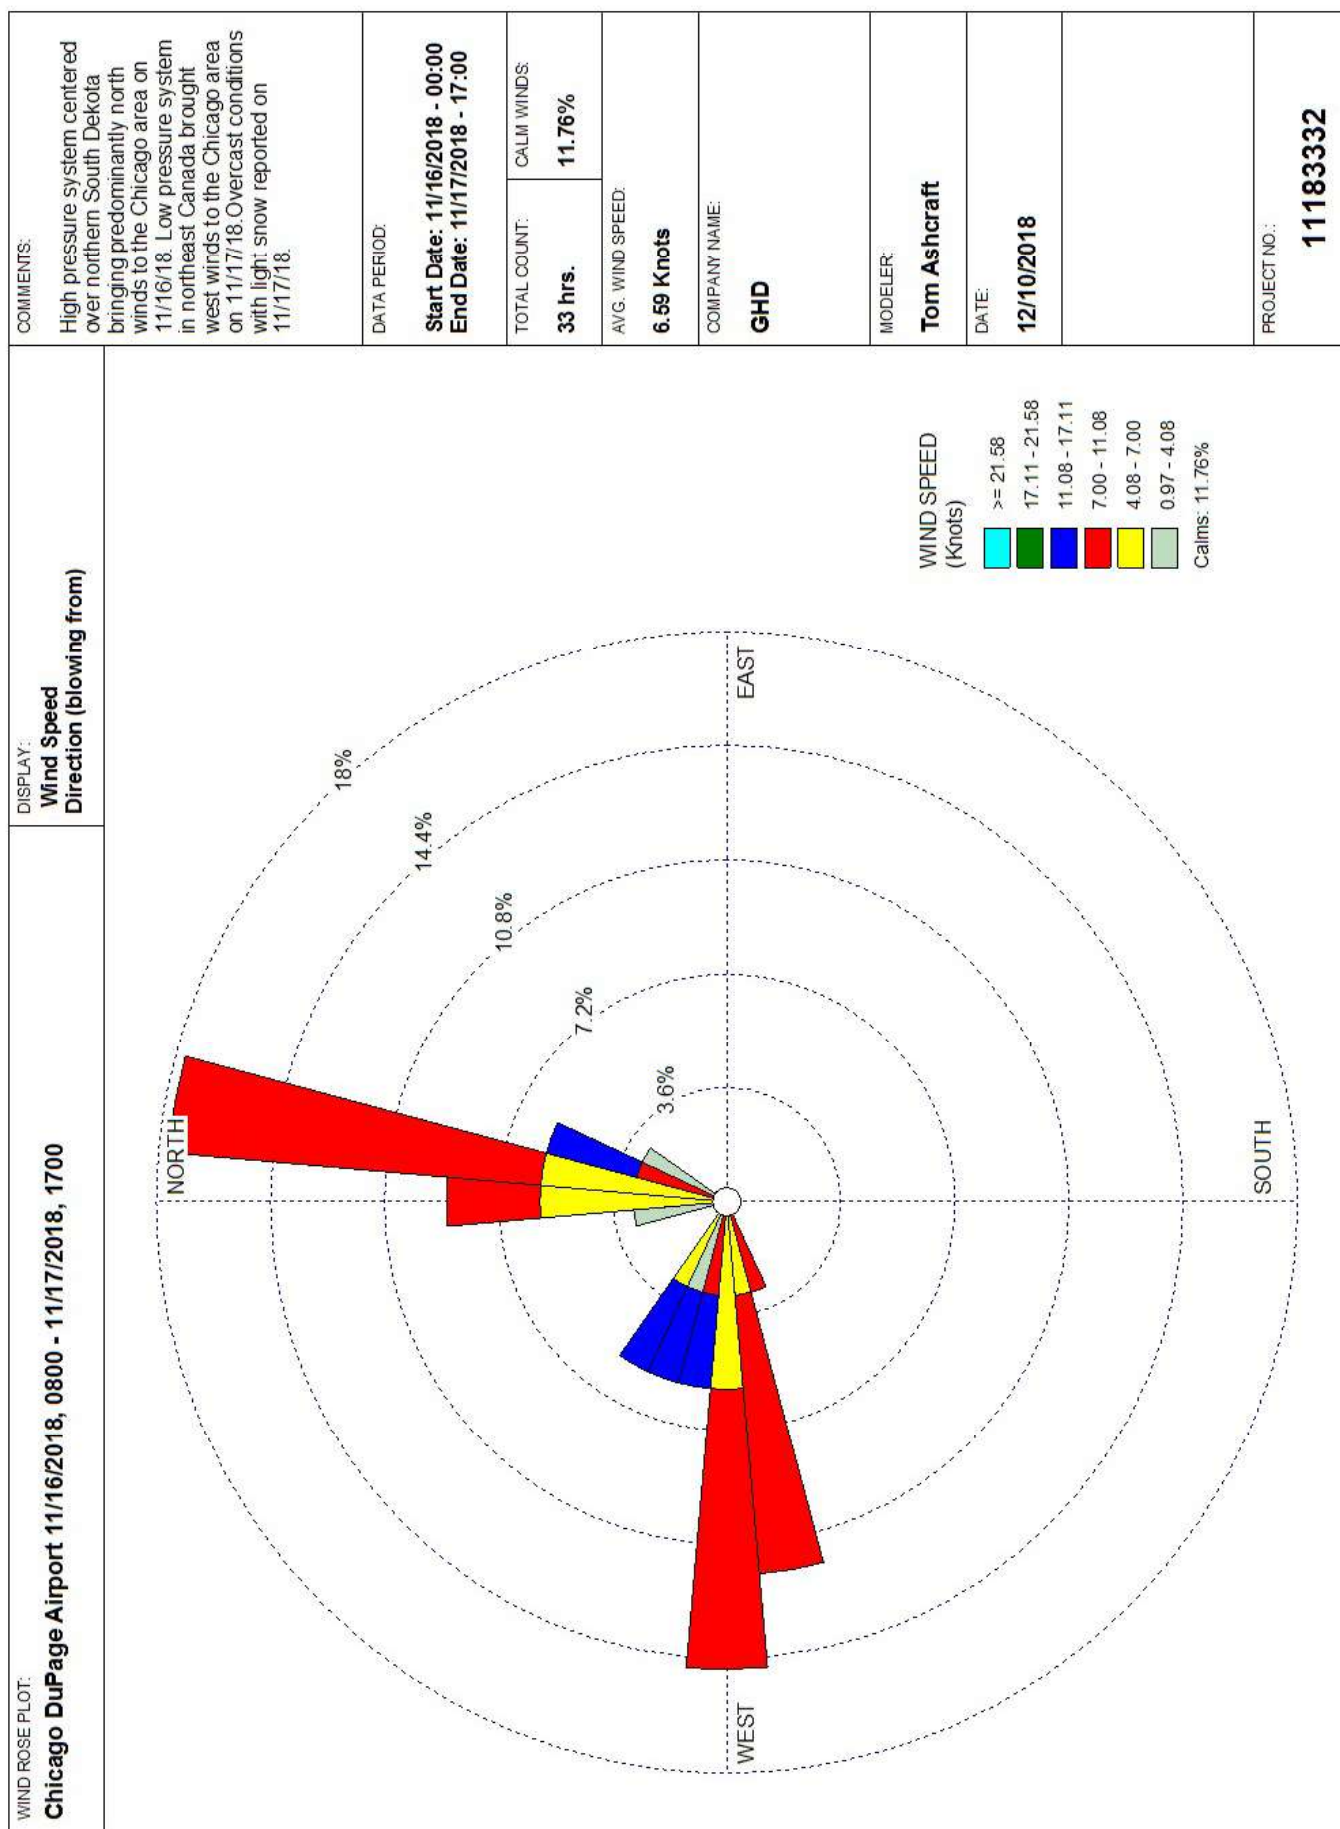
Wind Rose Map

Throughout the sampling period (approximately 0800 on 11/16/2018 to 1700 on 11/17/18), the wind was blowing predominantly from the West and the North according to Wind Rose data retrieved from the Chicago DuPage Airport and the Chicago Midway Airport. Appendix B contains a Wind Rose plot of the meteorological data, which depicts the direction and speed *from which* the wind was blowing during the entire sample period. Based on these data, as well as on-site observations by sampling personnel, all samples to the north and west of both Sterigenics facilities may be considered upwind sample locations during the sampling period.
